NEW YORK STATE DEPT OF ENVIRONMENTAL CONSERVATION ALBANY F/6 13/13  
NATIONAL DAM SAFETY PROGRAM. PALMER FALLS DAM, UPPER HUDSON RIV--ETC(U)  
AUG 80 J B STETSON DACW51-79-C-0001  
NY-145 NL

REPORT DOCUMENTATION PAGE		READ INSTRUCTIONS BEFORE COMPLETING FORM
1. REPORT NUMBER	2. GOVT ACCESSION NO. AD-A093025	3. RECIPIENT'S CATALOG NUMBER
4. TITLE (and Subtitle) Phase I Inspection Report Palmer Falls Dam Upper Hudson River Basin, Saratoga & Warren Counties, NY Inventory No. 145		5. TYPE OF REPORT & PERIOD COVERED Phase I Inspection Report National Dam Safety Program

PHASE I REPORT  
NATIONAL DAM SAFETY PROGRAM

Name of Dam Palmer Falls Dam, NY145

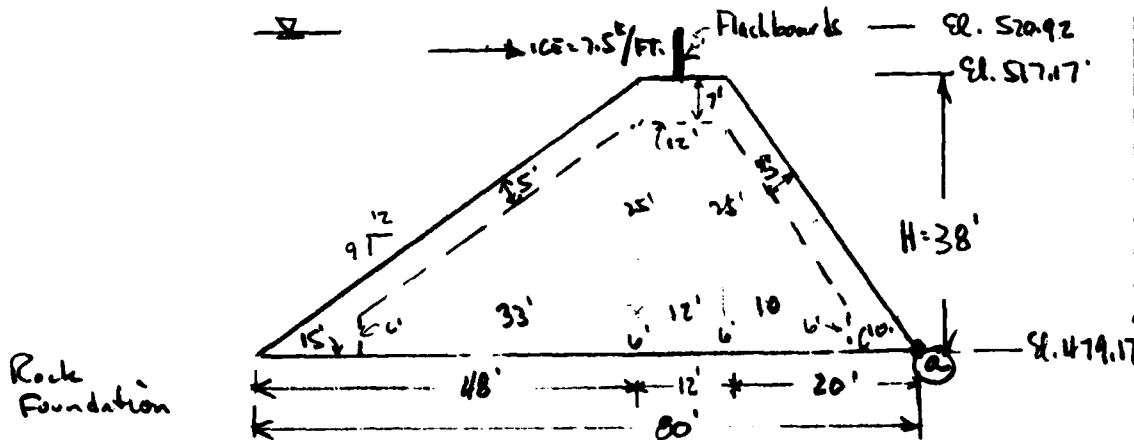
Assumed Cross-Section and Loading Conditions - Easterly Section

Note: Dam section selected at location near to maximum height (Pier 6). Upstream and downstream thickness represents weighted avg between buttresses.

Note 19' cc between buttresses, buttresses 4' wide the section of dam 19' long

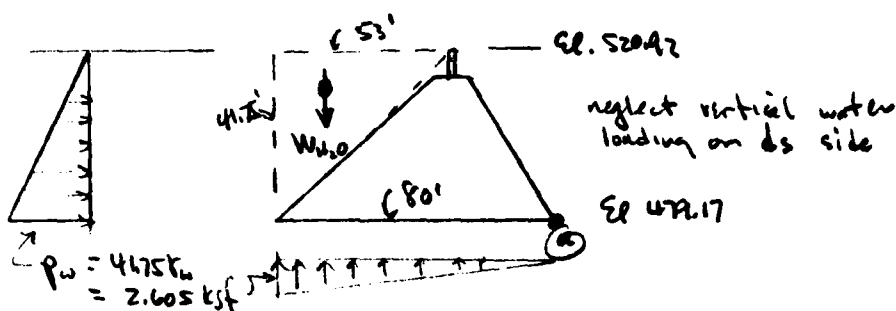
Case I: WL @ Normal Operating Level (Top of Flashboards)

(a)  $M_a$  causing overturning due to lateral  $H_2O$  pressure =  $(H') \left( 2.605 \times \frac{41.75}{3} \times \frac{41.75}{3} \right)$   
no uplift  
(16) (757 K) = 1420312 / 0.16

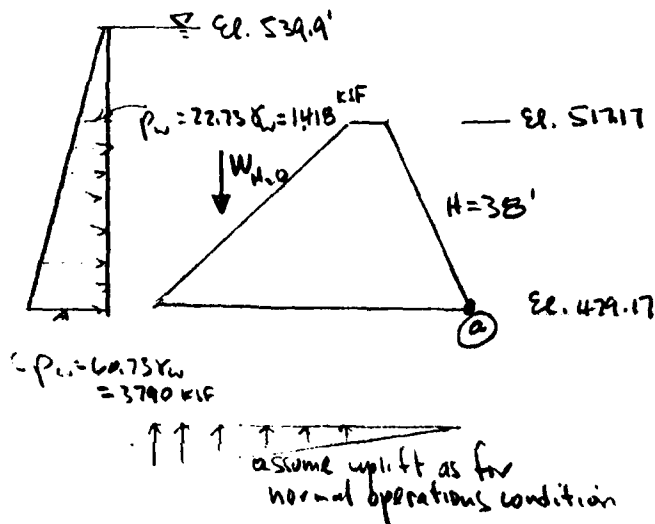
Case III. WL @  $\frac{1}{2}$  PMF Elevation, Flashboards Failed

- a) assume weight water on upstream face as for normal operations case, uplift as for normal operations case, lateral  $H_2O$  pressure increases

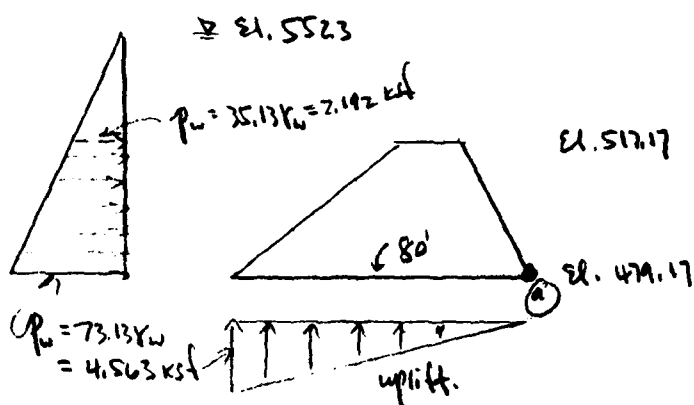
Case IV. WL @ PMF Elevation, Flashboards Failed

1. assume weight of water on upstream face due to full height of water, assume uplift results from full height of upstream water level

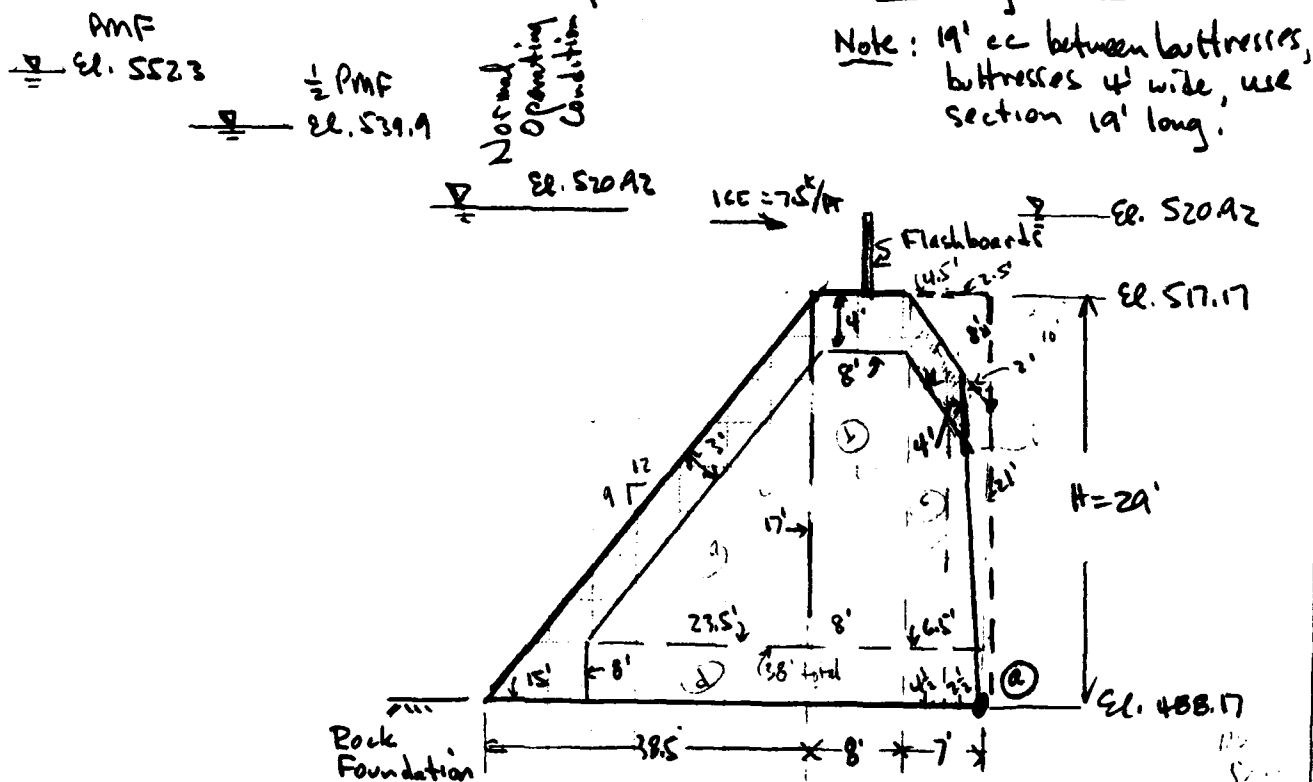
### Assumed Cross-Section and Loading Conditions - Westerly Section

$$\begin{aligned} \text{Wt. of 19' long section} &= (19 \times 15) \left[ \left( \frac{1}{2} \times 38.5 \times 29 \right) + (15 \times 29) - \left( \frac{1}{2} \times 7 \times 8 \right) - \left( \frac{1}{2} \times 2 \times 24 \right) \right] - \\ &\quad - (15 \times 15) \left[ \left( \frac{1}{2} \times 17 \times 23.5 \right) + (8 \times 17) + \left( \frac{6.5 \times 5}{2} \times \frac{17+13}{2} \right) + (37.5 \times 8) \right] = \\ &= (19 \times 15 \times 944.3) - (15 \times 15 \times 722) = 1065 \text{ K} \end{aligned}$$

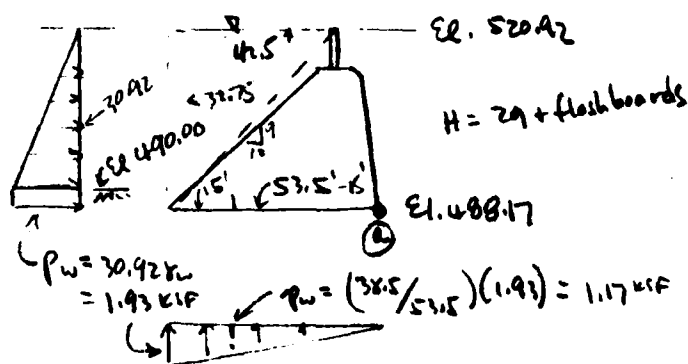
Case I • WL @ Normal Operating Condition (Top of Flashboards), No Ice

Overturning - case (a), uplift acting on entire plan area of damMa causing overturning due to lateral H<sub>2</sub>O pressure, uplift (assume base slab of rock/concrete acts as raft)

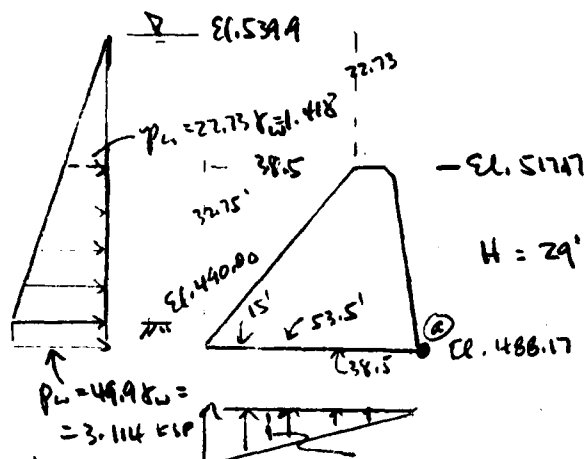
Case III. WL @  $\frac{1}{2}$  PMF Elevation, Flash boards failed

causing overturning due to horiz.  $H_2O$  pressure, normal uplift on entire plan area

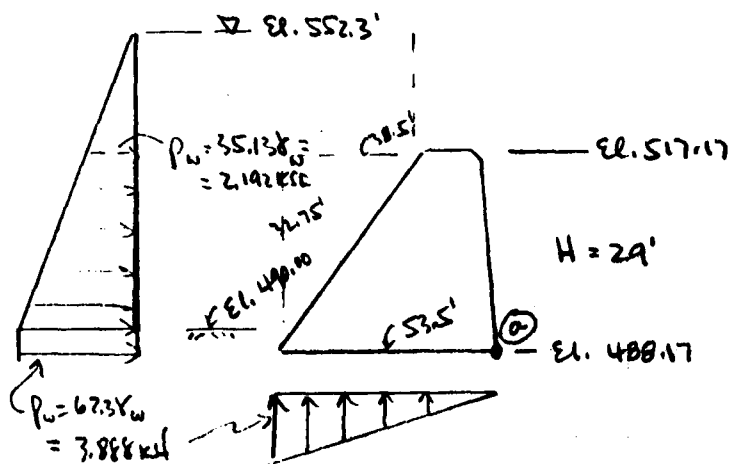
Case IV • WL @ PMF Elevation, Flashboards Failed

$M_a$  causing overturning due to horiz.  $H_2O$  pressure, normal uplift on entire plan area
